# Geotechnical Data Report

**MSDGC East Ohio Sewers  
10240775 Gilbert Avenue at Casino Sewer Repair  
Cincinnati, Hamilton County, Ohio**

Terracon Project No. N1195302

**Geotechnical Data Report**  
**MSDGC East Ohio Sewers**  
**10240775 Gilbert Avenue at Casino Sewer Repair**  
**Cincinnati, Hamilton County, Ohio**  
**Terracon Project No. N1195302**  
**March 8, 2023**

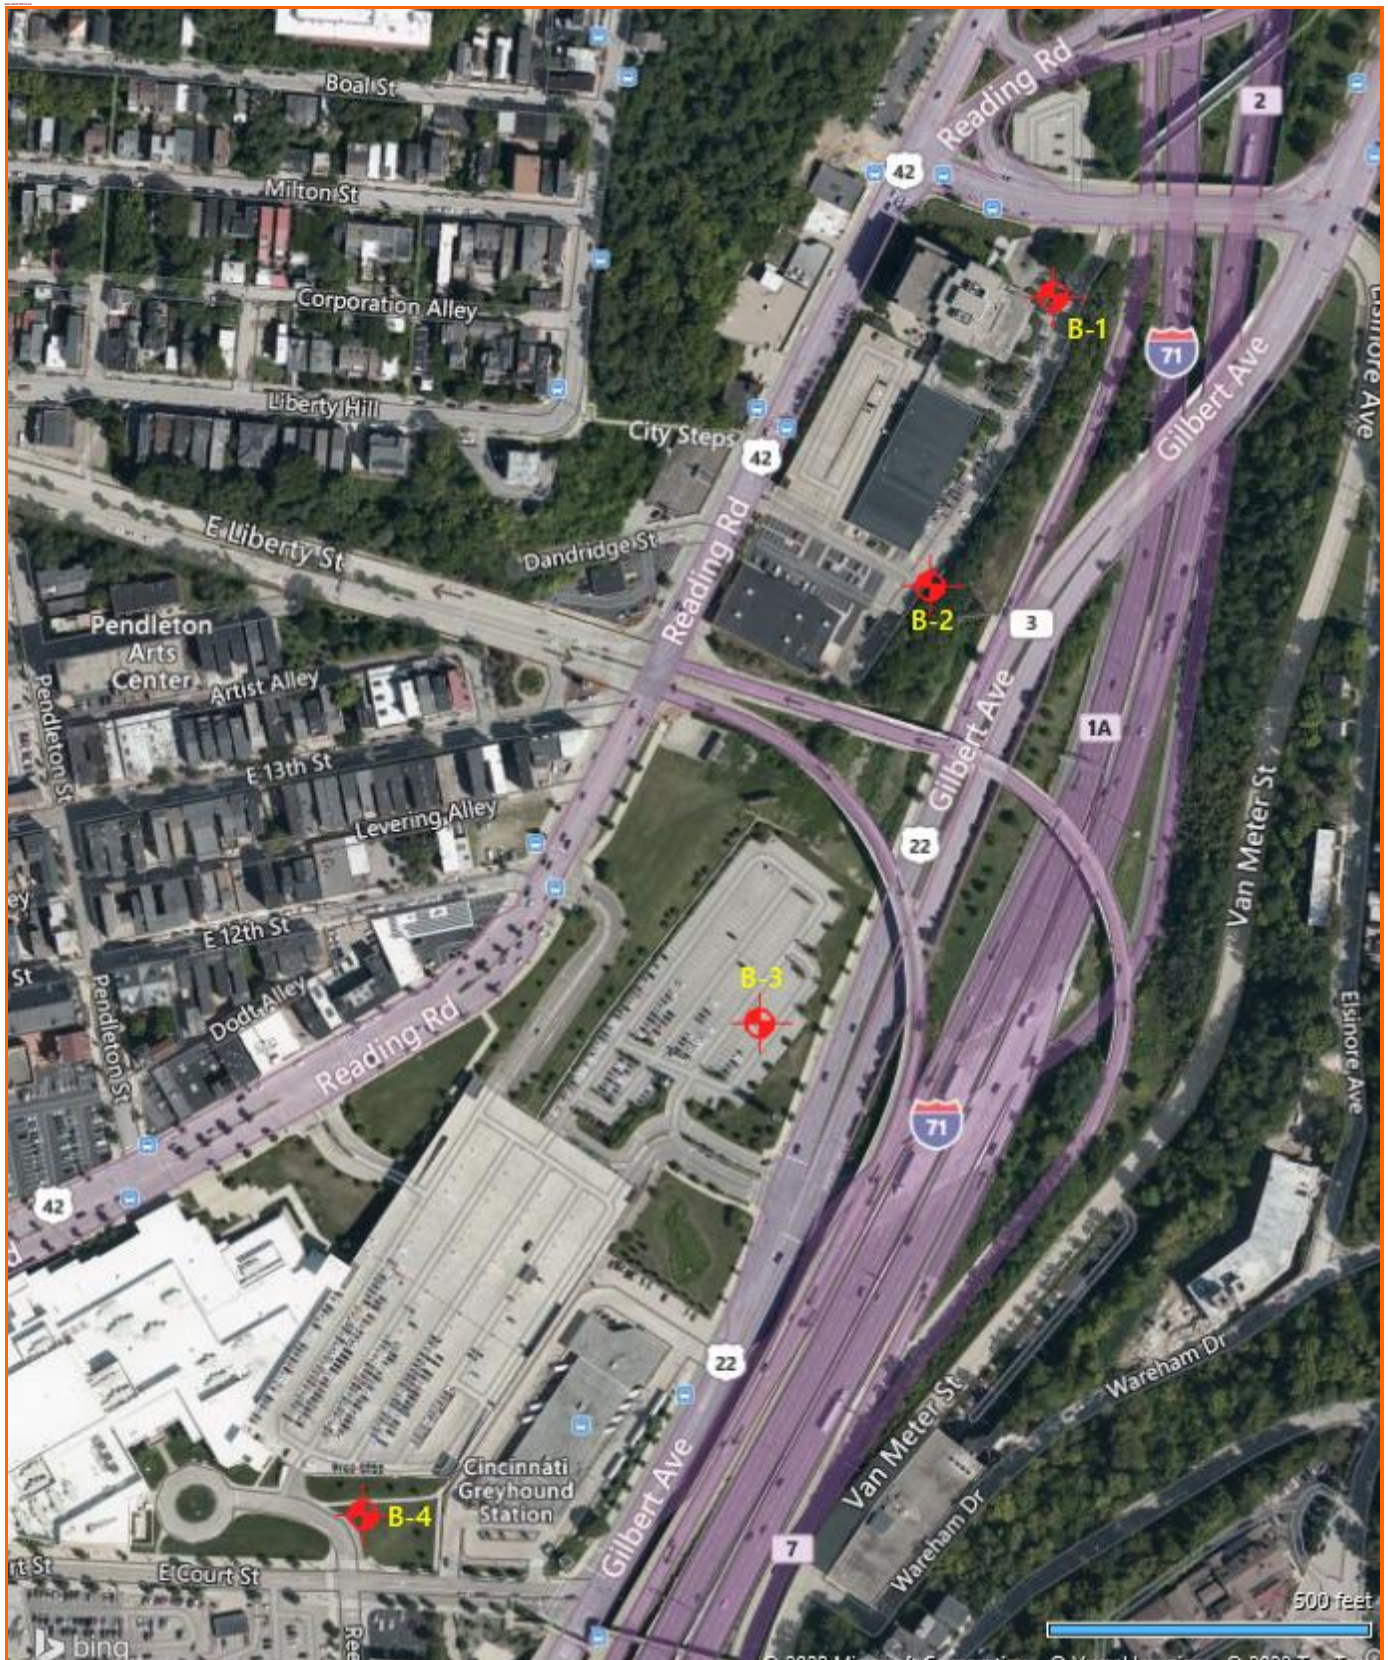
## EXPLORATION PLAN

DIAGRAM IS FOR GENERAL LOCATION ONLY, AND IS NOT INTENDED FOR CONSTRUCTION PURPOSES

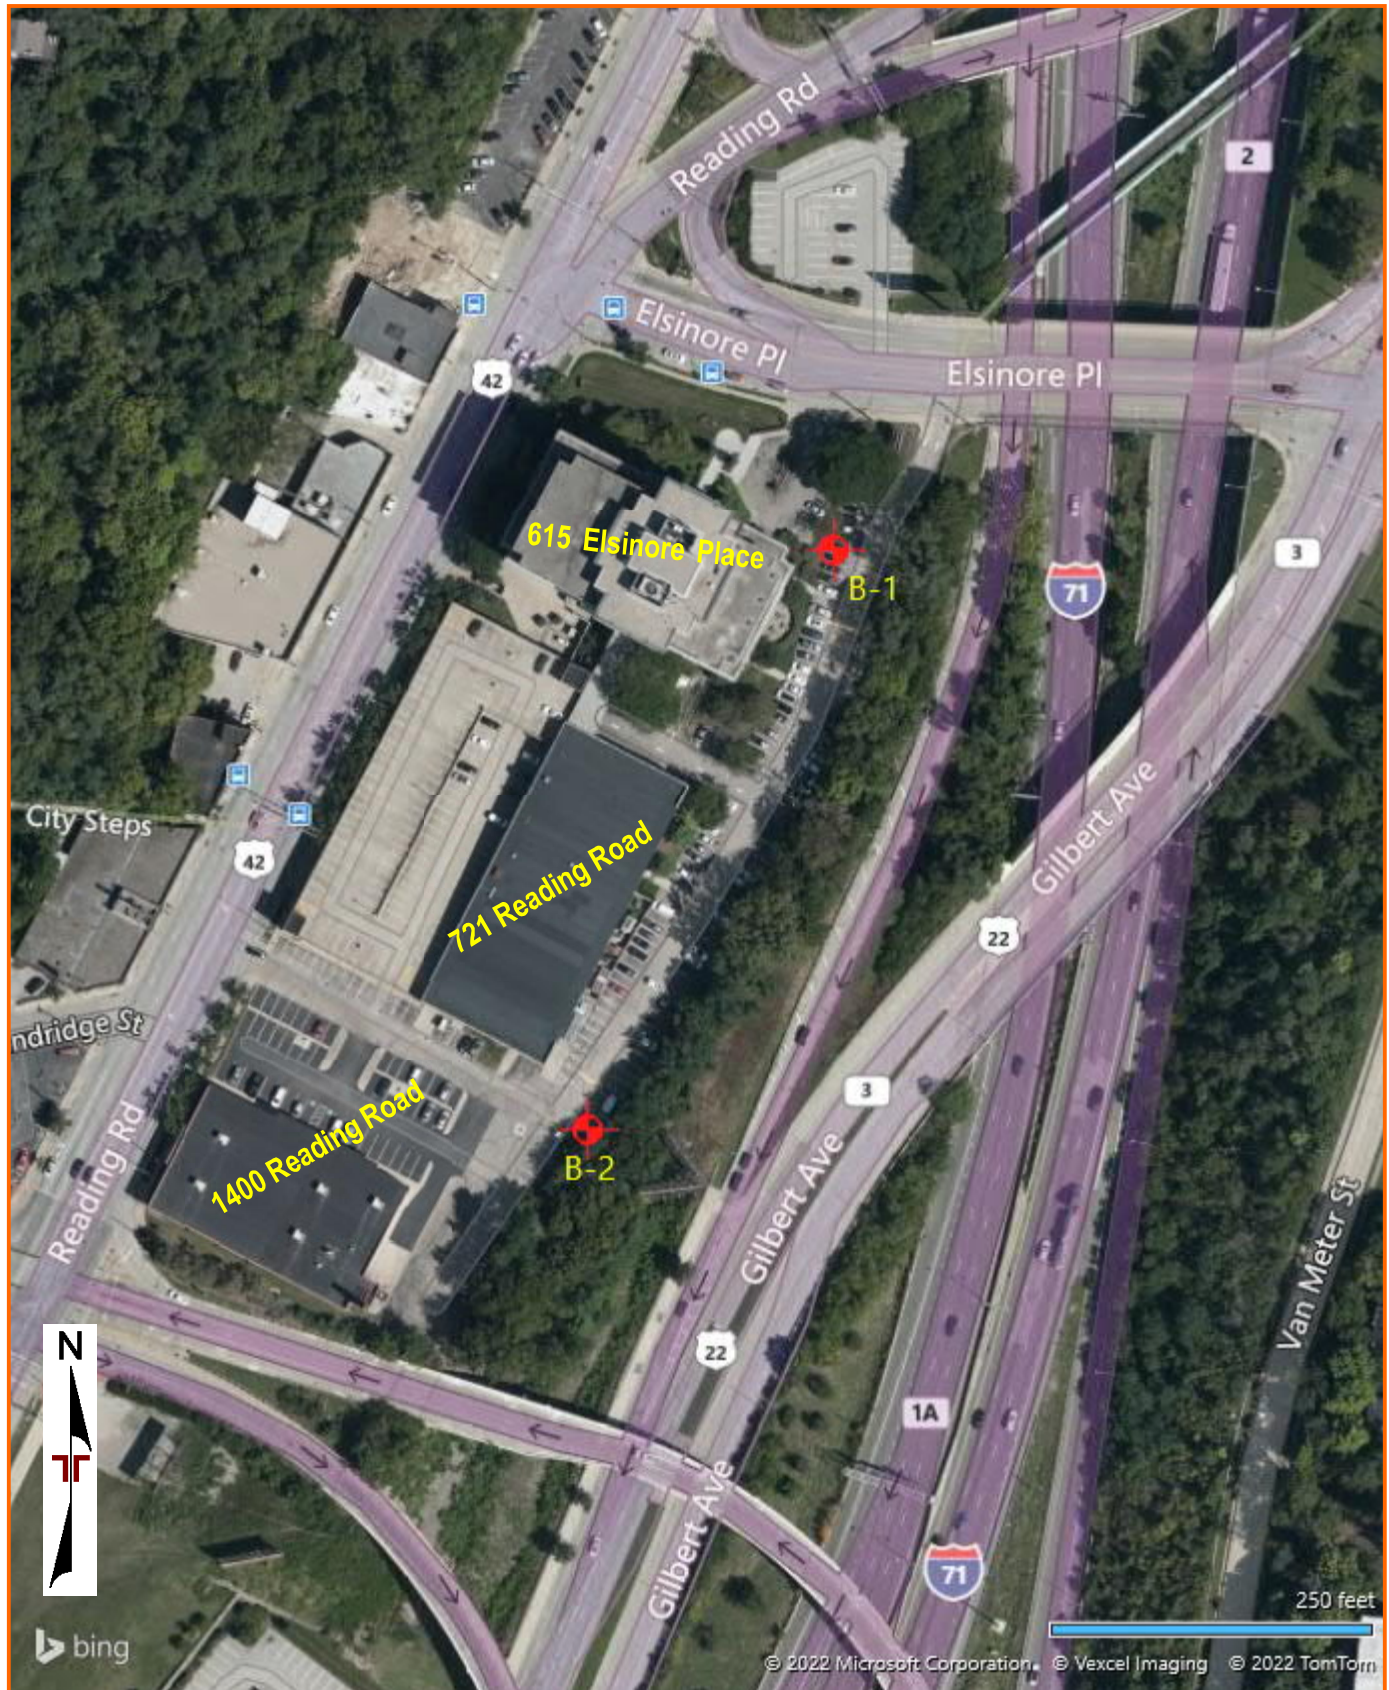
**EXPLORATION PLAN**

DIAGRAM IS FOR GENERAL LOCATION ONLY, AND IS  
NOT INTENDED FOR CONSTRUCTION PURPOSES
